Design Options for a Nature Park at McAllis Point

**Texas A&M University at Galveston
MARS 680 Capstone Class Project**

**By: Nicole Ekstrom
Jordan Payne
Doug Peters**

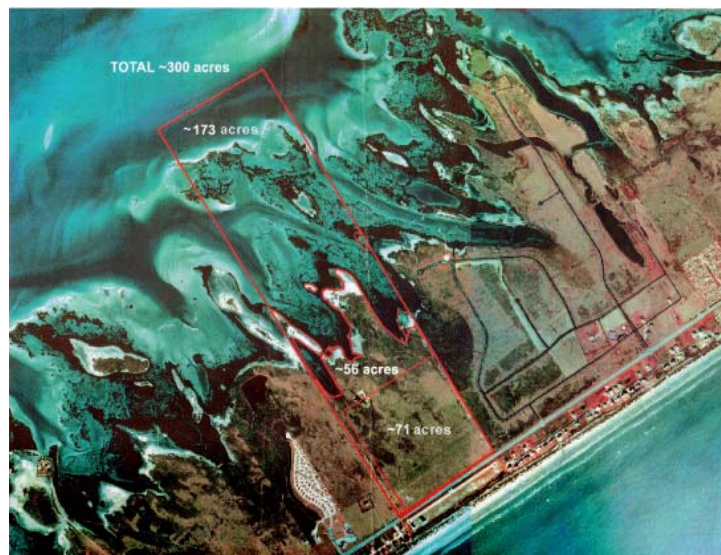
Figure 2. Location of McAllis Point, showing sections of property.

McAllis Point property is divided into three sections; 173 acres of water and wetlands owned by the state, 56 acres of mostly lowland bayfront property with a narrow connection to FM 3005, and 71 acres of uplands (Figure 2). In January 2006, TPL signed an option agreement with the McAllis Point landowner to acquire the land, which was valued at \$5 million. This agreement expired April 5, 2006.⁶ Because the TPL did not have all the funds necessary to purchase the entire property before April 5, a partnership with the GLO was formed to help TPL in its preservation efforts. The GLO agreed to buy and hold the 127-acre portion of the property for one year to allow TPL to raise the necessary funds to buy the property. If the funds can be raised in time, then TPL will have first right of purchase on the land and will pay fair market value for the property. To date, TPL has raised approximately \$2.5 million from federal land conservation funding, the City of Galveston, Galveston County, and members of the community, and plans to acquire the 56 acres of bayfront property with that money.⁷ Additional funding is necessary to acquire the remaining 71 acres of upland coastal prairie. Although TPL is securing the funding for the purchase of McAllis Point, the land will ultimately be turned over to Galveston County, who will then allocate the park management to a local non-governmental organization.⁸

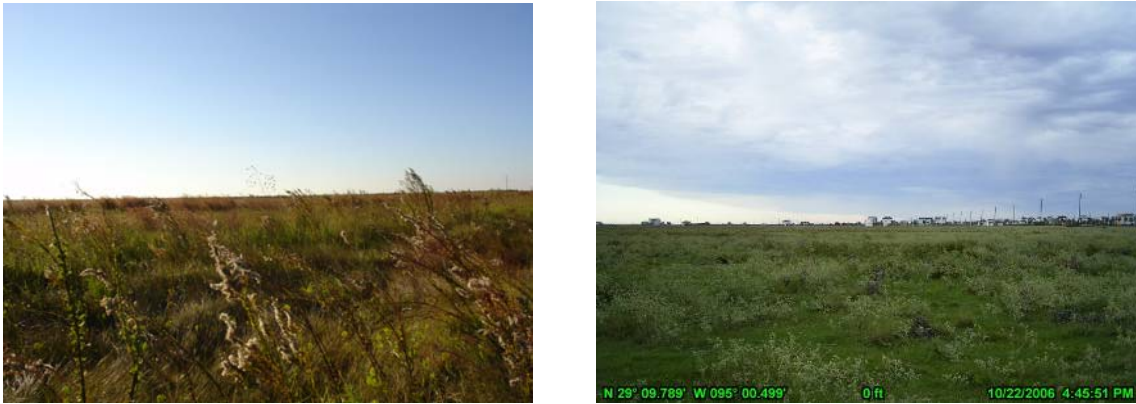
Figure 4. Comparison of relatively undisturbed natural coastal prairie on Galveston Island (left) with disturbed upland habitat on McAllis Point property (right).

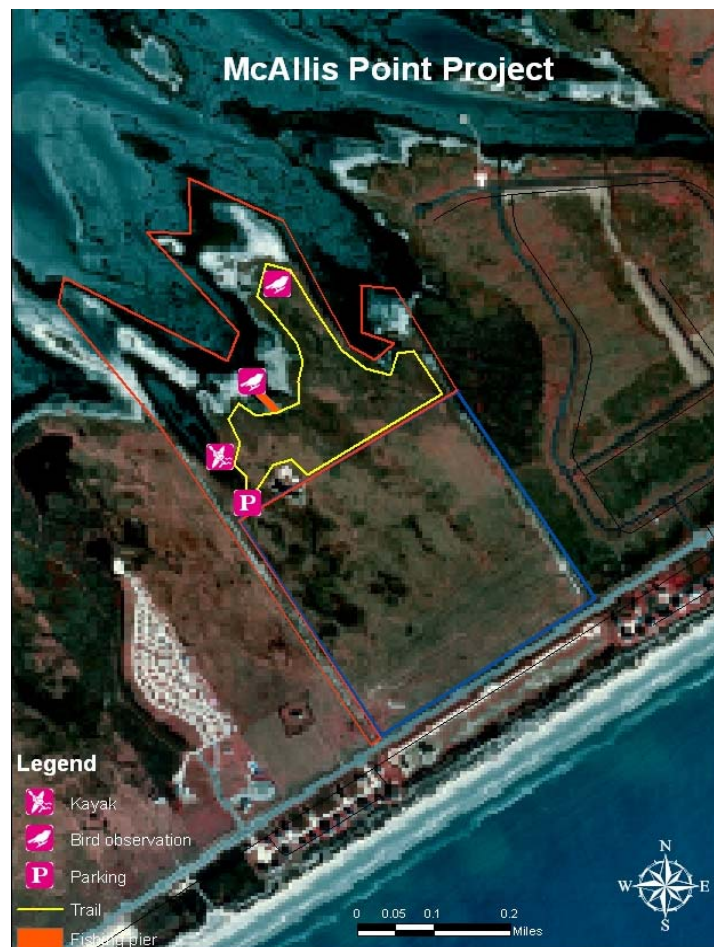
Figure 5. Park design with 56 acres

Due to the restrictions on the 56 acres, the only improvements listed above that can be developed is a small parking lot, a hiking/bicycling/running trail, the kayak launch, small observation points, and a fishing pier. Even with these limited amenities, the layout still accommodates natural preservation and some human and recreational opportunities.

A proposed road will go in along the western side of the property since an entrance to the property already exists. A small parking lot, for approximately 10 cars, would be located at the end of the road. A kayak launch point would be located close enough to the parking lot for ease, while the trails follow the perimeter of the 56 acres.

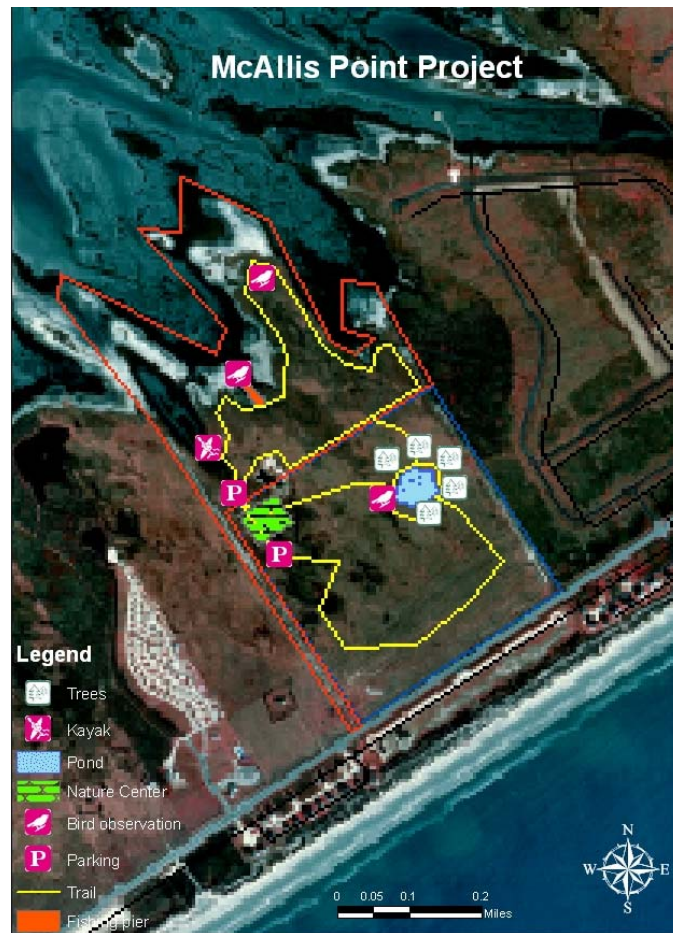
Figure 6. Park design with entire 127 acres.

The overall design was created to minimize disturbance to the 127 acres while enhancing the value of the park and encourage its use. In addition to the improvements indicated in the 56 acre design, a nature/interpretative center would be built on the 71 acres. The center would provide educational opportunities for local schools, tourists and area residents. The incorporation of a kayak rental/storage area would facilitate access to the unique areas of the park and other parks only accessible by water while providing a source of funding for park maintenance. A freshwater pond with trees planted around it would be located along the eastern edge of the property. The trees and pond were designed to insulate the property from the adjacent residential area by increasing the natural aesthetic value while promoting species diversity.

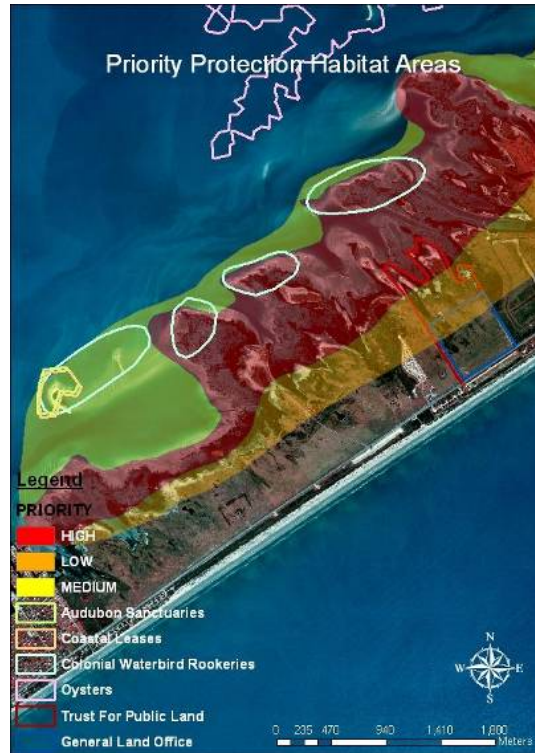
Figure 8. Map showing priority protected habitat areas in the area around McAllis Point
